# **Evaluation Of X-Ray Equipment Performance In Some Selected Hospitals Within Jos City, Plateau State, Nigeria**

**G.Z. Bongtim<sup>a</sup>, M. I. Ike-Ogbonna<sup>a</sup>, R.J. Bature<sup>a</sup>, M.D Tumba<sup>a</sup>, C. R. Maduka<sup>a</sup> and D. Obasiya<sup>a</sup>,**

<sup>a</sup> **Department of Physics, Faculty of Natural Sciences, University of Jos, Nigeria;**  
**\* Corresponding author: zinggodwin@gmail.com**

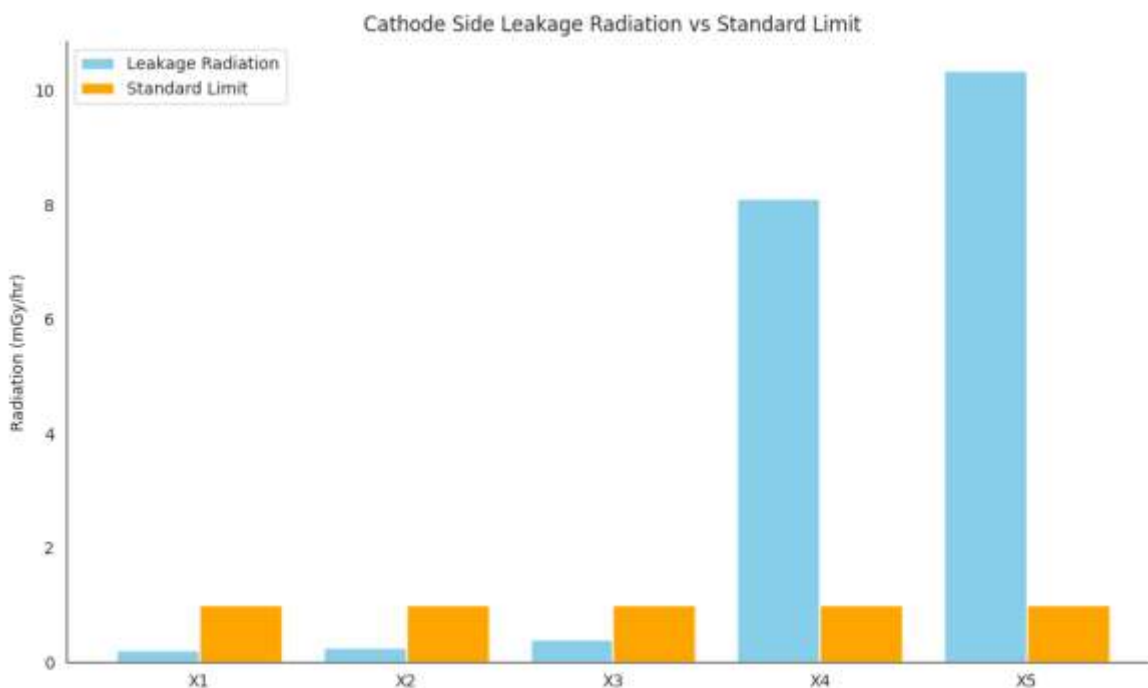
Figure 1 illustrates the leakage radiation measured on the cathode side of the X-ray machines (X1–X5) at a distance of 1 meter, compared to the standard limit of 1 mR/hr as recommended by the International Commission on Radiological Protection (ICRP). The results show that X1, X2, and X3 recorded leakage radiation levels of 0.22, 0.25, and 0.39 mR/hr, respectively, all well below the standard limit. However, X4 and X5 exhibited significantly higher leakage radiation at 8.10 and 10.34 mR/hr, respectively, exceeding the acceptable threshold by substantial margins.

The low leakage radiation in X1, X2, and X3 suggests effective shielding and maintenance of the X-ray tube housing, aligning with findings by [10], who reported that well-maintained X-ray units typically exhibit leakage radiation within safe limits. These facilities likely adhere to regular quality control (QC) protocols, ensuring compliance with radiation safety standards. Conversely, the elevated leakage radiation in X4 and X5 indicates potential issues such as degraded tube housing or insufficient shielding materials. This is concerning, as excessive leakage radiation poses risks to radiographers, patients, and the public, as highlighted by Nkuba and Nyanda [11], who found that 47% of units in their study had radiation levels above safe limits at key locations. The high leakage in X4 and X5 may be attributed to their older manufacturing years (2005 and 2019, respectively) or inadequate maintenance schedules, as older equipment is more prone to wear, as noted by Ofotokun and Umuze [12]. These findings underscore the need for immediate corrective actions, such as replacing or repairing the tube housing and enhancing shielding, to ensure compliance with ICRP standards and protect occupational and public health.

Figure 1: The Comparison of the Cathode Side Leakage Radiation at the Studied Facilities to the Standard Limit.

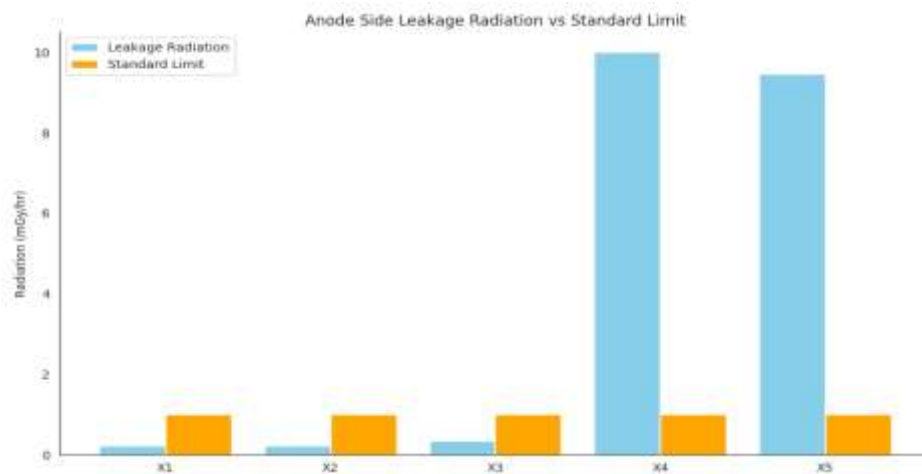
Figure 2 presents the anode-side leakage radiation for the X-ray machines, compared to the same ICRP standard limit of 1 mR/hr. Similar to the cathode side results, X1, X2, and X3 recorded low leakage radiation levels of 0.22, 0.23, and 0.35 mR/hr, respectively, indicating robust shielding on the anode side.

In contrast, X4 and X5 showed elevated levels at 10.00 and 9.47 mR/hr, respectively, exceeding the standard limit significantly.

The consistency of low leakage radiation in X1, X2, and X3 on both cathode and anode sides suggests symmetrical shielding integrity, which is critical for minimizing unintended radiation exposure. These results are comparable to Muhammad et al. (2018), who found that most X-ray units in their study complied with leakage radiation standards due to adequate shielding. However, the high leakage in X4 and X5 on the anode side mirrors the cathode-side findings, reinforcing concerns about equipment condition and maintenance. The slightly lower anode side leakage in X5 (9.47 mR/hr) compared to its cathode side (10.34 mR/hr) may indicate uneven wear or shielding deficiencies specific to the tube design. Effective shielding is essential for radiation safety [13], and the excessive leakage in X4 and X5 could increase the cumulative radiation dose to staff, particularly in high-workload settings. These findings highlight the urgency of conducting thorough QC assessments and implementing maintenance protocols to address shielding deficiencies in X4 and X5, ensuring alignment with ALARA (As Low As Reasonably Achievable) principles.

Figure 2. The Comparison of the Anode-Side Leakage Radiation at the Studied Facilities to the Standard Limit.

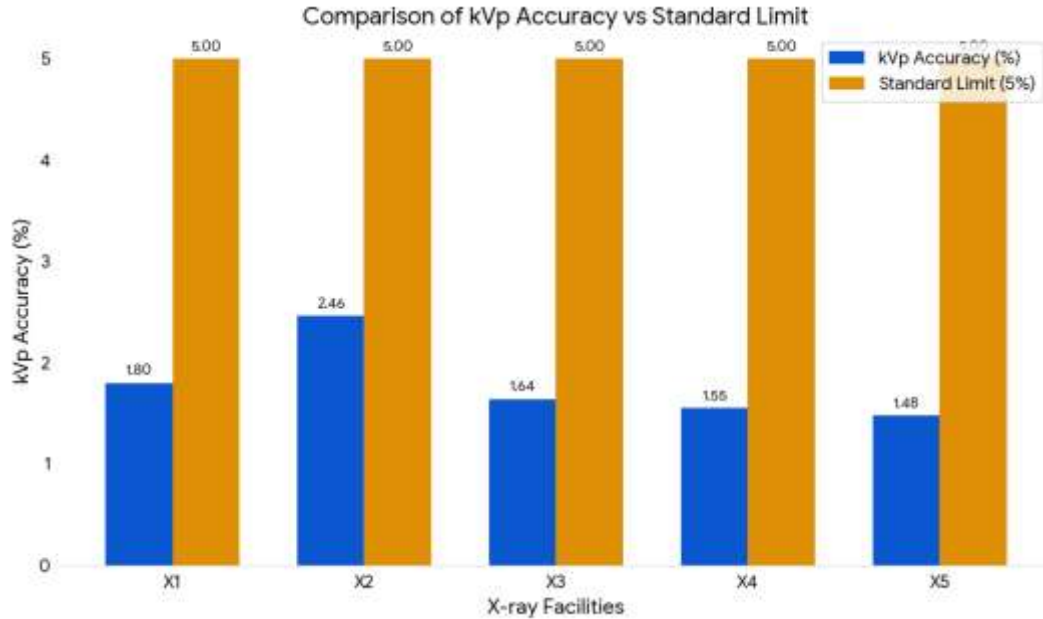
Figure 3 illustrates the kilovoltage (kVp) accuracy of the X-ray machines (X1–X5) at a selected tube voltage of 100 kVp, compared to the tolerance limit of  $\pm 5\%$  as recommended by the American Association of Physicists in Medicine [7]. The kVp accuracy, calculated as the percentage deviation between the set and measured tube voltages, was 1.80% (X1), 2.46% (X2), 1.64% (X3), 1.55% (X4), and 1.48% (X5), all well within the acceptable tolerance limit.

The consistent kVp accuracy across all facilities indicates that the X-ray machines are reliably delivering the selected tube voltage, which is critical for producing diagnostic images with appropriate contrast and minimizing patient radiation exposure. These results align with another study [10], which reported kVp accuracies of 90.32–96.77% across various tube voltage settings, attributing compliance to regular quality control (QC) checks. The slightly higher deviation in X2 (2.46%) compared to other facilities may reflect minor calibration drift, but it remains well within the AAPM tolerance, suggesting negligible impact on image quality or dose. Notably, X4, despite its older manufacture (2005) and issues with leakage radiation (Figures 1 and 3), demonstrates excellent kVp accuracy (1.55%), indicating that its voltage control system is still functional. This finding contrasts with [14], who noted that older X-ray units often exhibit poorer kVp accuracy due to electronic wear. The high kVp accuracy across all facilities supports the reliability of exposure parameters, as emphasized by [6], and contribute to consistent image quality and patient safety. However, ongoing QC is essential to maintain this performance, as even small deviations in kVp can significantly affect radiation output and image contrast, as noted by [15].

Figure 3: The Comparison of the Kilovoltage Accuracy at the Various Facilities to the Standard Limit.

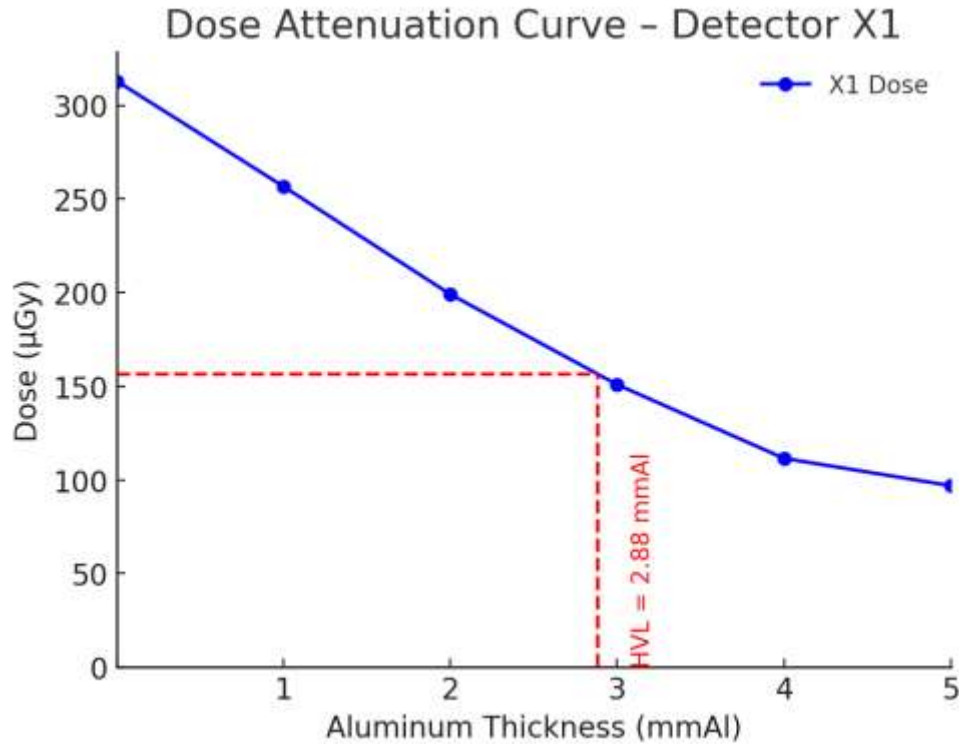
Figure 4 depicts the Half Value Layer (HVL) determined for X1, showing an HVL of 2.88 mm Al at 100 kVp and 20 mAs. The HVL, which measures the aluminum thickness required to reduce the X-ray beam intensity by half, was calculated by plotting radiation dose against aluminum thickness and applying interpolation. This value exceeds the IAEA minimum of 2.3 mmAl for 80 kVp, indicating adequate beam filtration. The HVL of 2.88 mm Al suggests that X1's beam is effectively filtered, minimizing low-energy radiation that contributes to patient dose without improving image quality. Other findings [10] reported that 96.77% of X-ray machines in their study met HVL standards. X1's modern design (manufactured in 2022) likely incorporates advanced filtration materials, contributing to compliance with beam quality requirements. Regular monitoring remains essential, as filter degradation over time can reduce HVL and increase patient exposure.

Figure 4. A graph showing the half-value layer of Al at the X1 X-ray facility using 100 kVp and 20 mAs.

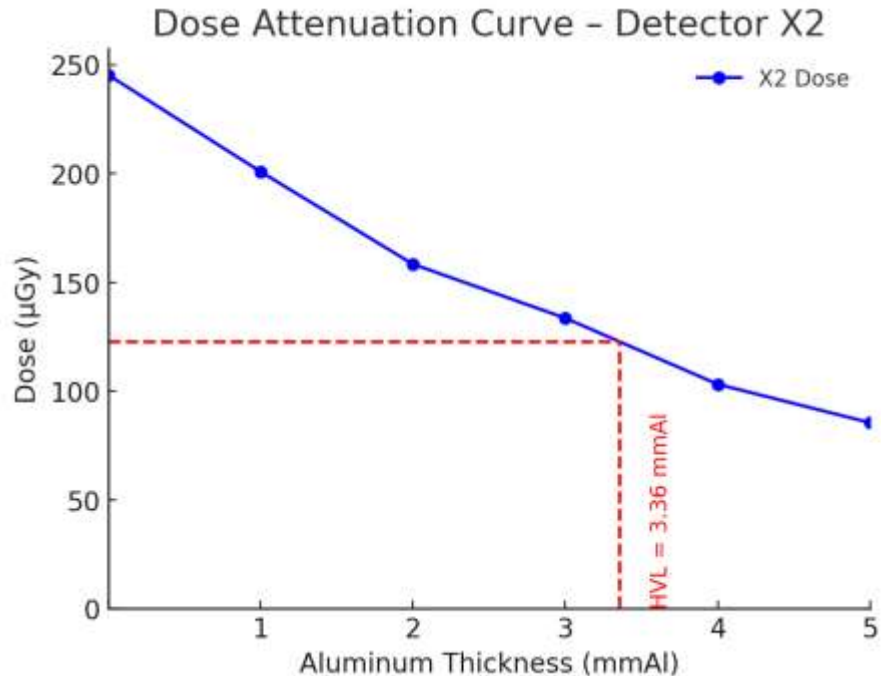
Figure 5 shows the HVL for X2, determined as 3.36 mm Al at 100 kVp and 20 mAs, well above the IAEA minimum of 2.3 mm Al. This high HVL indicates excellent beam filtration, reducing unnecessary radiation exposure to patients. The HVL of 3.36 mmAl reflects X2's robust filtration system, likely due to its recent manufacture (2021) and installation (2022). This result is consistent with Ogbonna, M. I. I. et al. (2024) [16], who found that newer X-ray units exhibited superior beam quality due to effective filtration. The high HVL ensures that only higher-energy X-rays reach the patient, minimizing skin dose, as supported in another study (Delis, H., et al. 2017) [5]. Continued QC testing is recommended to sustain this performance, as environmental factors or equipment wear could affect filtration efficacy over time.

Figure 5. A graph showing the half-value layer of 3.36 mm Al at the X2 X-ray facility using 100 kVp and 20 mAs.

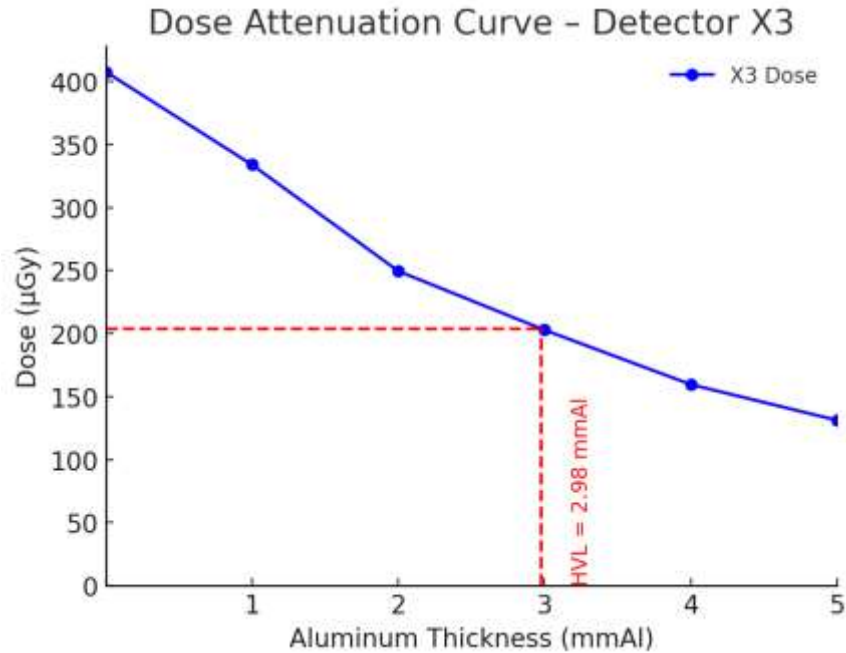
Figure 6 illustrates the HVL for X3, calculated as 2.98 mm Al at 100 kVp and 20 mAs, exceeding the IAEA minimum requirement of 2.3 mm Al. This indicates that X3's X-ray beam is adequately filtered, ensuring safe and effective diagnostic imaging. The HVL of 2.98 mmAl suggests that X3, manufactured in 2021, maintains a high standard of beam quality, comparable to X1 and X2. This aligns with a study by Nkuba, L. L., & Nyanda, P. B. [11], who reported that 98.2% of units in their study met HVL standards due to proper filtration. The slightly lower HVL compared to X2 may reflect minor variations in filter material or tube design but remains well within acceptable limits. Regular HVL assessments should be conducted to ensure ongoing compliance, particularly as X3 is relatively new and expected to maintain high performance.

Figure 6. A graph showing the half-value layer of 2.98 mm Al at the X3 X-ray Facility using 100kVp and 20 mAs.

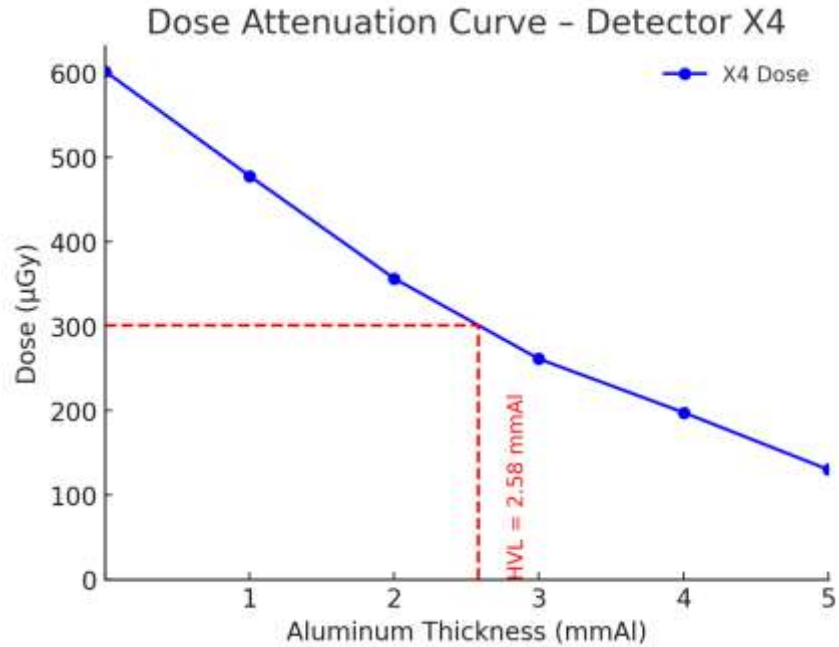
Figure 7 presents the HVL for X4, determined as 2.58 mm Al at 100 kVp and 20 mAs, slightly above the IAEA minimum of 2.3 mm Al. While compliant, this HVL is lower than that of X1, X2, and X3, indicating marginal beam filtration. The HVL of 2.58 mmAl suggests that X4's filtration is adequate but less robust than newer units, possibly due to its older manufacture (2005). This finding aligns with Njiki, C. D., et al. [17], which noted that older X-ray machines often exhibit lower HVL values due to filter wear or outdated designs. The marginal HVL could be linked to the high leakage radiation observed in earlier figures. This underscores the need for filter replacement or equipment upgrades to enhance beam quality, as recommended by Bem, T. T., et al. [18]. Enhanced QC protocols are essential to monitor and improve X4's performance, ensuring patient safety and diagnostic efficacy.

Figure 7: A graph showing the half-value layer of 2.58 mm Al at the X4 X-ray Facility using 100kVp and 20 mAs.

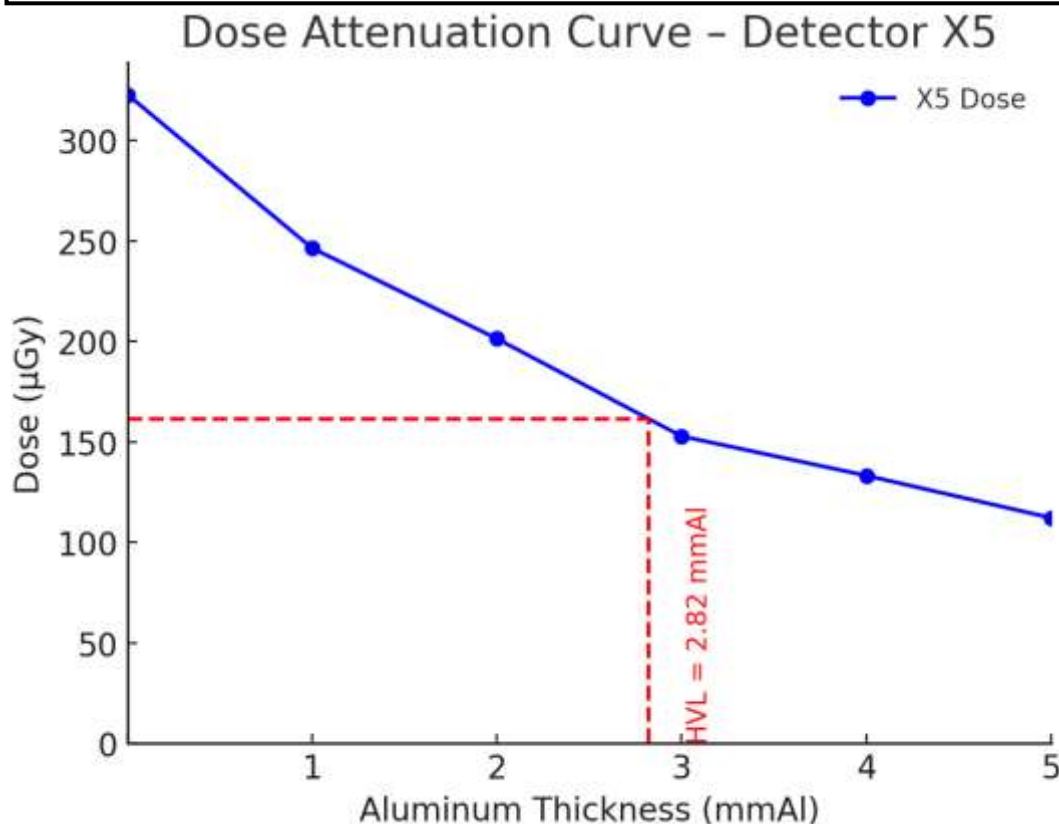
Figure 8 shows the HVL for X5, determined as 2.82 mm Al at 100 kVp and 20 mAs. This value exceeds the IAEA minimum of 2.3 mmAl, indicating that X5 has a robust filtration system. Compared to X4 (HVL of 2.58 mmAl), X5 demonstrates a higher HVL, suggesting better beam quality. This result supports the conclusion that X5's filtration system is effective in reducing low-energy, non-diagnostic radiation. Its performance is consistent with modern standards and contributes to safer imaging practices. Continued quality control is advised to maintain this level of beam filtration over time.

Figure 8. A graph showing the half-value layer of Al at the X5 X-ray Facility using 100kVp and 20 mAs.
