# Causes And Remedial Measures Of Building Cracks: A Case of Enugu Area, Southeastern Nigeria

The problem of cracking in building is becoming difficult task for engineers in recent time. This study therefore investigates the causes of building cracks on a two-floor structure in Awgu, Enugu State, South-eastern Nigeria. Four basic methods comprising of building inspection, foundation probe, non-destructive evaluation and cone penetration test were methods employed to determine the exact cause(s) of the cracks on structure. The width, pattern and conditions of the cracks were identified during the building inspection. Test results from Non Destructive Evaluation indicate that about 65.1% of the structural elements – columns, beams and slab met acceptable levels of concrete strength while about 34.9% fell below the threshold value of 25N/m<sup>2</sup> and this is most unlikely to have contributed to the building defects. It was established from analyses of other tests conducted on the building that inadequate foundation considerations which resulted in differential settlements is a key factor responsible for the various cracks. The foundation footings were found to be inducing variat

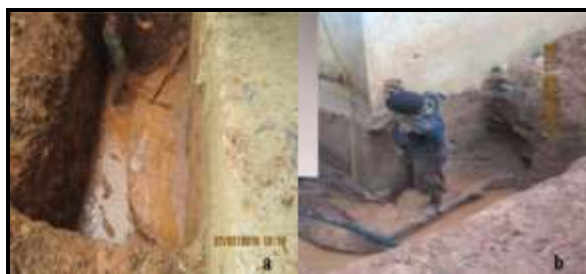
Fig 2: Foundation probe showing (a) the column base at the left hand side of the building (b) the measurement of foundation depth

Foundation probe which involves excavation of the soil below the foundation depth (Fig. 2) was conducted on the building to visualize how the foundations were resting on the soil and to also determine foundation type/depth adopted for the construction with respect to the terrain.

The foundations of the building consist essentially of isolated column pad footings about 1.6m x 1.6m x 0.3m (Depth) each located at about 1.7m from the ground floor slab to foundation depth.

The height of the substructure from natural ground level (NGL) to foundation depth is 1.3m and ground water table was noticed at 0.8m depth from NGL during probe.

The probe further indicates that the foundation type adopted for the building was not suitable for a water-logged area since it may not support even distribution of load over the entire area of the foundation when submerged or in its saturated state.

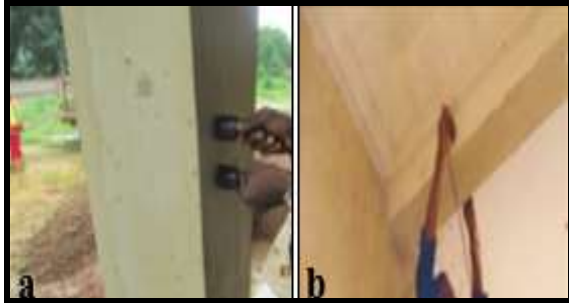
Fig. 3: testing the structural elements with PUNDIT, (a) ground floor column (b) first floor beam.

The Non-Destructive Structural Integrity Test was conducted to ascertain the capabilities of the structure in bearing imposed loads (Fig. 3). This test is related to an assessment of structural adequacy and reliability. The test was performed by using Portable Ultrasonic Non-Destructive Digital Indicating Tester (PUNDIT) which works on the principle of ultrasonic pulse velocity (UPV). Three (3) test points were randomly selected to get a good representation/result on each structural element for the building.

Tests results from Non Destructive Evaluation indicate that about 65.1% of the structural elements – columns, beams and slab met acceptable levels of concrete strength while about 34.9% were considered of poor quality concrete mix.

The results as above do not constitute very grave errors of construction and may not have contributed largely to the existence of cracks and defects as noticed.

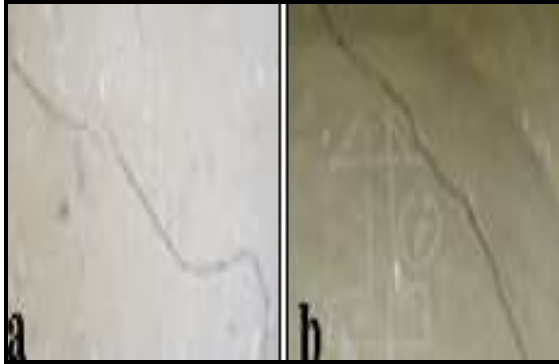
Fig. 4: Some of the observed cracks, (a) diagonal crack on ground floor internal wall (b) diagonal crack on ground floor external wall

Vertical, diagonal and horizontal cracks were noticed on the ground & first floors internal & external walls of the building (Fig. 4 and Fig. 5).

The Vertical and Diagonal cracks were caused by differential settlement of foundation elements while the Horizontal cracks may likely have been due to applied loading as a result of imposed stresses from the metal roof structure.

Vertical, diagonal and horizontal Cracks in this study were induced by excessive roof load on the inadequately sized structural elements thereby putting the masonry walls in compression resulting to cracks. Contributory causes also include adverse effects of foundation inadequacy.

1. Increasing the sizes or stiffening the vertical support elements such as the columns. The adequacy of 450mm x 225mm size should be checked. All elements rated poor should equally be stiffened with particular attention paid to ground floor columns since they are responsible for transmission of load to the foundations.
2. Sections of the building where cracks were observed should be repaired by grouting the affected sections with adequate mortar mix.
3. Foundation underpinning which is the process of stiffening the foundation of an existing building be carried out.
4. Load analysis should be conducted in order to optimize the structural configuration of the building.
5. Construction of effective storm water drainage system, building perimeter apron, eavestroughs and roof gutter should be ensured to prevent degradation and saturation of the soils around the foundation.

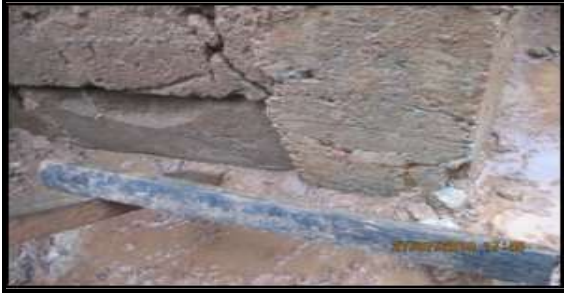
Fig. 6: punching shear failure on foundation column

Considering the vertical load and the imposed stresses of the metal roof structure, the sizes of columns may be considered inadequate for effective vertical load transmission to the substructure.

This is most likely considered as one of the errors leading to defect in the building which induced the punching shear failure at the column/base joint noticed.

Punching shear failure was also noticed at the foundation/column joint on the posterior right hand side of the building during the probe (Fig. 6). Foundation peripheral beams were evident at the upper layers of the foundation grid.

The foundation type for the construction method adopted is designed to accommodate settlements within tolerable limits but rise in water table due to seasonal changes may have produced additional settlements which can threaten the integrity of the structure ultimately leading to cracks in walls.

Therefore, inadequate foundation consideration in view of the potential for differential settlement due to seasonal variations in the water table could have affected the integrity of the building.
